Manhole Inspection Summary

Manhole # S11S__012MH

Location Address: **810 S. Caton Ave**

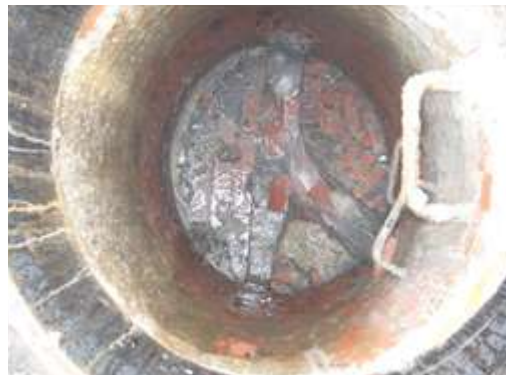
Top View

signs of infiltraton from top

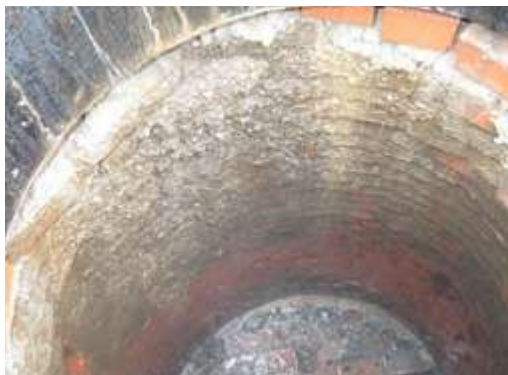
Defect 5

Infiltration: ☐ None ☐ Joint ☐ Cracks ☐ Mortar ☐ Roots ☒ **Wall**

Infiltration in chimney and corbel

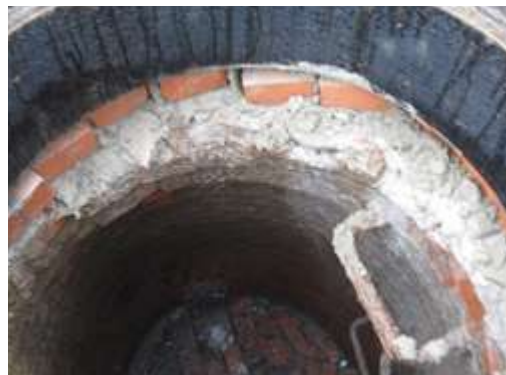
Defect 2

Condition: ☐ Sound ☐ Cracked ☐ Root Intrusion ☒ **Loose Brick** ☐ Deteriorated

Steps Count: **7** Missing: **0** ☒ **Corroded**

Loose bricks and mortar/chimney infiltration/corroded steps

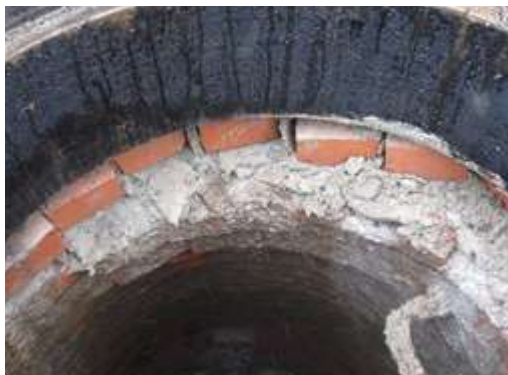
Defect 1

Loose bricks and mortar

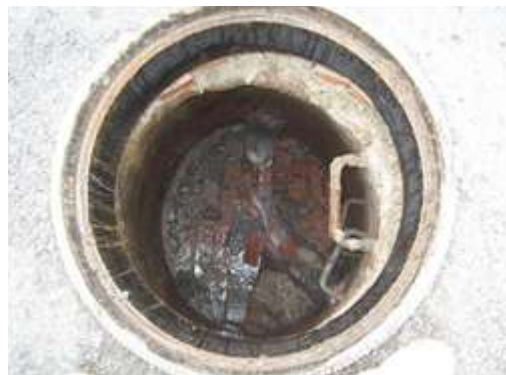
Defect 3

Frame Offset: **3** (in.) Condition: ☒ Sound ☐ Cracked ☐ Leaks

frame offset

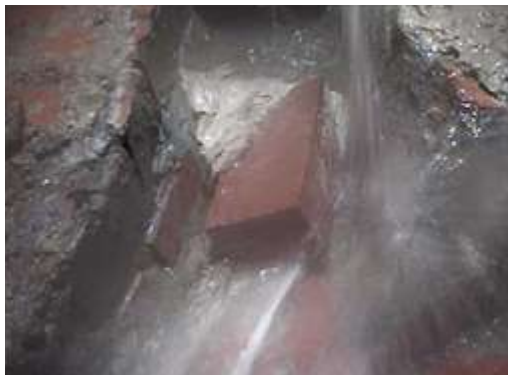
Defect 4

Condition: ☐ Sound ☐ Cracked ☐ Root Intrusion ☒ **Deteriorated** ☐ Leaks ☒ **Debris**

Debris in channel

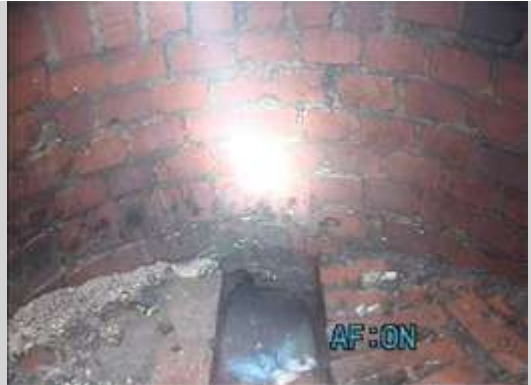
12 O'Clock Outflow

Pipe Height: **8.4** (in.) Rod and Bar (Angled)
Pipe Material: **Clay** ☐ Pipe Lined
Invert Depth: **8.50** (ft.) Flow Characteristics: **Slow**
Deposits: ☒ None ☐ Mud ☐ Sludge ☐ Debris ☐ Grease
Silt Depth: **0** (in.) Deposits Extent:
Infiltration: **Evidence** Pipe Seal Cond: **Unknown**

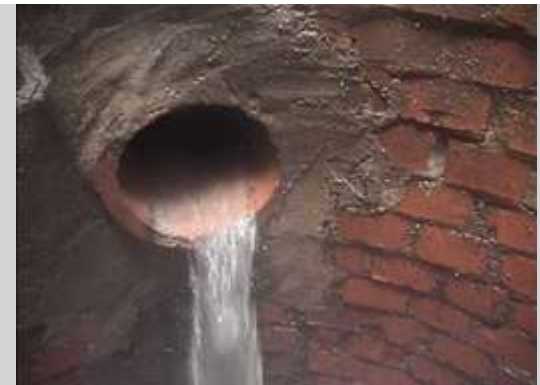
4 O'Clock Inflow

Pipe Height: **8.4** (in.) Rod and Bar (Angled)
Pipe Material: **Clay** ☐ Pipe Lined
Invert Depth: **5.10** (ft.) Flow Characteristics: **Slow**
Deposits: ☒ None ☐ Mud ☐ Sludge ☐ Debris ☐ Grease
Silt Depth: **0** (in.) Deposits Extent:
Infiltration: **Evidence** Pipe Seal Cond: **Unknown**

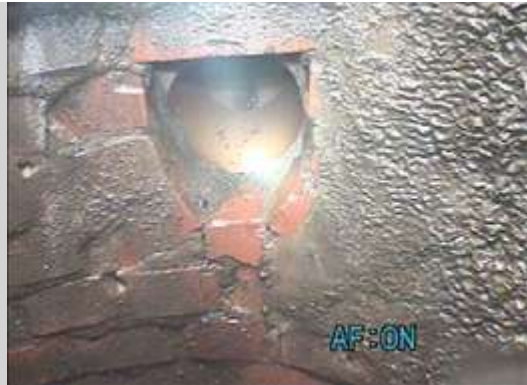
Evidence of infiltration in Barrel
